**Flood Control Project Maintenance  
Levee Inspections**

## Maintenance Issue Types Only, Levee Inspection Report By Mile - Fall 2015

### Reclamation District No. 2089 Stark

Waterway	Bank	Unit Miles	Inspection Start/End	Inspector
Unit No. 01 Old River	Right	1.51	09/29/2015 09/29/2015	Maksim Khashchuk

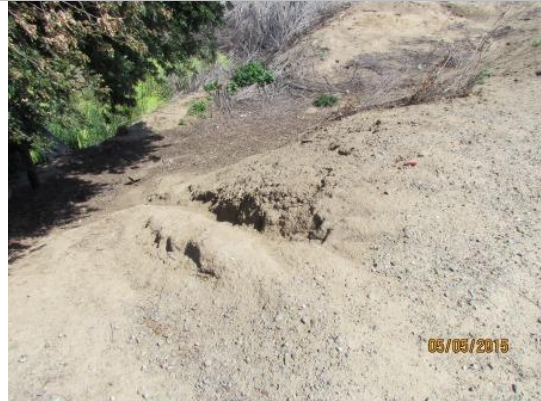
Photo 1 of 1 : FA\_2015\_RD2089\_316\_1\_20150910\_00001.jpg

LM Start	0.04	Rating **	M	Issue No.	1
LM End	0.04	Issue Type +	Ma	Location *	LS
Category	Earthen Levee			GPS Latitude/Longitude	
				Start	End
Item	Encroachments			37.811474 °	37.811474 °
				-121.385573 °	-121.385573 °
DWR ID	DWR_RD2089_01_s_2012_1				
Action/Comments					
Stairway					
Inspector Comments: Steps have been cut into the levee slope, this could become an erosion point, please fill and compact.

View of the stairs eroding into the landside levee slope.

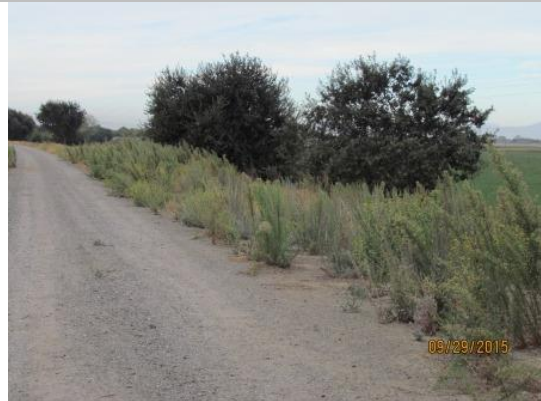
Photo 1 of 1 : FA\_2015\_RD2089\_316\_42\_20151005\_00036.jpg

LM Start	0.05	Rating **	M	Issue No.	42
LM End	0.13	Issue Type +	Ma	Location *	LS
Category	Earthen Levee			GPS Latitude/Longitude	
				Start	End
Item	Vegetation			37.811418 °	37.811048 °
				-121.385877 °	-121.387242 °
DWR ID	DWR_RD2089_01_f_2013_42				
Action/Comments					
Remove the wild growth other than native grasses from the levee slopes.

View of the tall vegetation obstructing visibility of the landside levee slope.

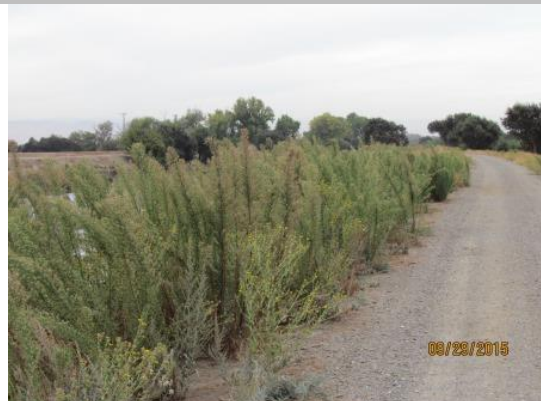
Photo 1 of 1 : FA\_2015\_RD2089\_316\_22\_20151005\_00037.jpg

LM Start	0.06	Rating **	M	Issue No.	22
LM End	0.10	Issue Type +	Ma	Location *	WS
Category	Earthen Levee			GPS Latitude/Longitude	
				Start	End
Item	Vegetation			37.811381 °	37.811201 °
				-121.386027 °	-121.386722 °
DWR ID	DWR_RD2089_01_f_2015_22				
Action/Comments					
Control annual grass and weeds on the levee slopes and easements.

View of the tall vegetation obstructing visibility of the waterside levee slope.

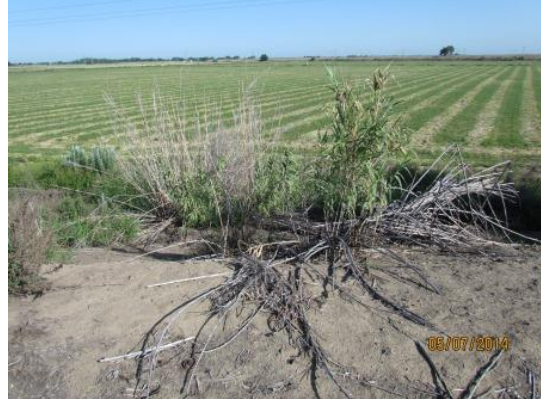
Photo 1 of 1 : FA\_2015\_RD2089\_316\_940\_20150910\_00030.jpg

The LMA is actively trying to remove the vegetation on the landside levee slope and toe.

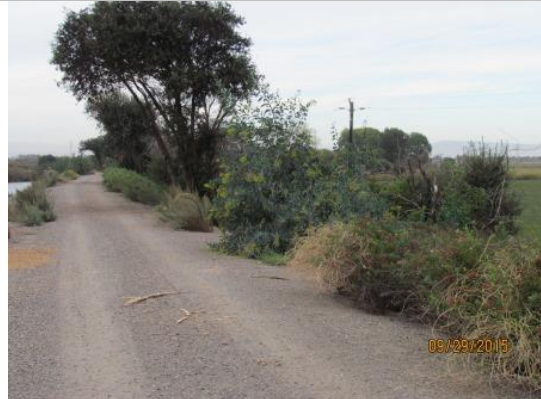
Photo 1 of 1 : FA\_2015\_RD2089\_316\_12\_20151005\_00038.jpg

LM Start	0.27	Rating **	U	Issue No.	12
LM End	0.39	Issue Type +	Ma	Location *	LS
Category	Earthen Levee			GPS Latitude/Longitude	
				Start	End
Item	Vegetation			37.810319 °	37.809740 °
				-121.389510 °	-121.391645 °
DWR ID	DWR_RD2089_01_s_2012_12				
Action/Comments					
Remove the wild growth other than native grasses from the levee slopes. Inspector Comments: Access and visibility completely blocked. 11/10/2011 issue has not changed.

Thick brush and wild rose completely block access and visibility of landside slope and toe.

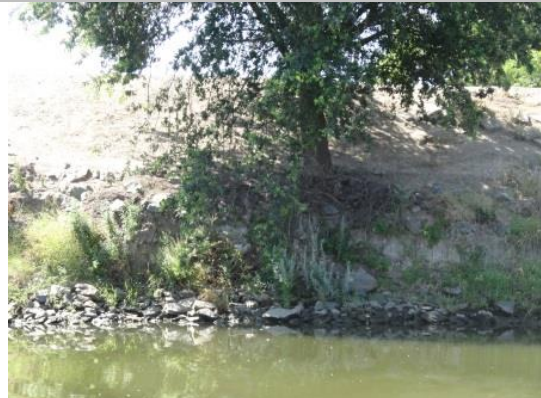
Photo 1 of 1 : SJR2015\_RD2089U01RM29.94\_1.jpg

LM Start	0.32	Rating **	M	Issue No.	6
LM End	0.33	Issue Type +	Ma	Location *	WS
Category	Supplemental			GPS Latitude/Longitude	
				Start	End
Item	DWR Erosion Survey			37.809833 °	37.809833 °
				-121.390261 °	-121.390261 °
DWR ID					
Action/Comments					
Inspector Comments: 06/25/2015: The erosion is below a large oak tree. Vegetation is visible around the eroiosn site. [2015 Site ID:RD2089U01RM29.94]

Front view of the erosion site. Note the large tree above the erosion.

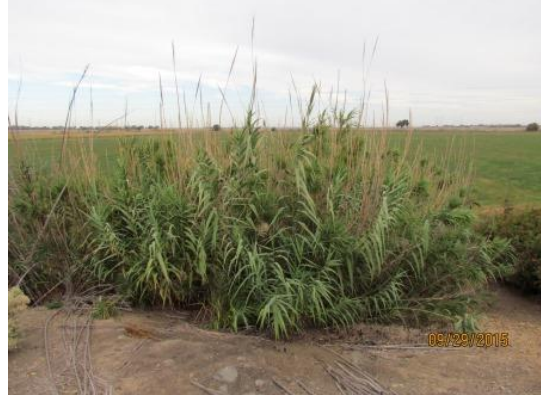
Photo 1 of 1 : FA\_2015\_RD2089\_316\_19\_20151005\_00039.jpg

LM Start	0.33	Rating **	U	Issue No.	19
LM End	0.33	Issue Type +	Ma	Location *	LS
Category	Earthen Levee			GPS Latitude/Longitude	
				Start	End
Item	Vegetation			37.809983 °	37.809983 °
				-121.390678 °	-121.390678 °
DWR ID	DWR_RD2089_01_s _ 2012_19				
Action/Comments					
Remove the wild growth other than native grasses from the levee slopes. Inspector Comments: Bamboo completely blocks access and visibility.11/10/2011 Arundo has been trimmed back from the roadway, but still completely blocks access and visibilit to the landside slope. This plant was improperly identified as bamboo in previous inspections.

Arundo has been trimmed back from the road, but needs to be removed so that it does not obstruct visibility and access to the landside toe.

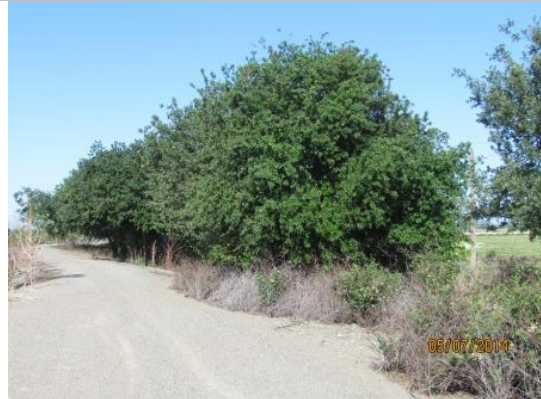
Photo 1 of 1 : FA\_2015\_RD2089\_316\_946\_20150910\_00031.jpg

LM Start	0.37	Rating **	U	Issue No.	946
LM End	0.37	Issue Type +	Ma	Location *	LS
Category	Earthen Levee			GPS Latitude/Longitude	
				Start	End
Item	Trim / Thin Trees			37.809865 °	37.809865 °
				-121.391303 °	-121.391303 °
DWR ID	DWR_RD2089_01_s _ 2012_946				
Action/Comments					
Trim trees to at least five feet above ground level.

Trees on levee slope obstruct access and visibility.

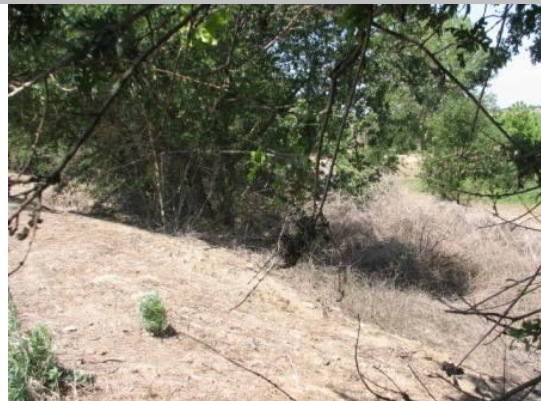
Photo 1 of 1 : FA\_2015\_RD2089\_316\_28\_20150910\_00016.jpg

LM Start	0.41	Rating **	U	Issue No.	28
LM End	0.46	Issue Type +	Ma	Location *	LS
Category	Earthen Levee			GPS Latitude/Longitude	
				Start	End
Item	Vegetation			37.809593 °	37.809507 °
				-121.391963 °	-121.392907 °
DWR ID	DWR_RD2089_01_s _ 2012_28				
Action/Comments					
Remove the wild growth other than native grasses from the levee slopes.					
Inspector Comments: Vegetation is too thick to allow access and visibility.

05/24/2011 Photo shows thick dead vegetation and continuation of trees in area that are preventing access and visibility of landside slope and toe.

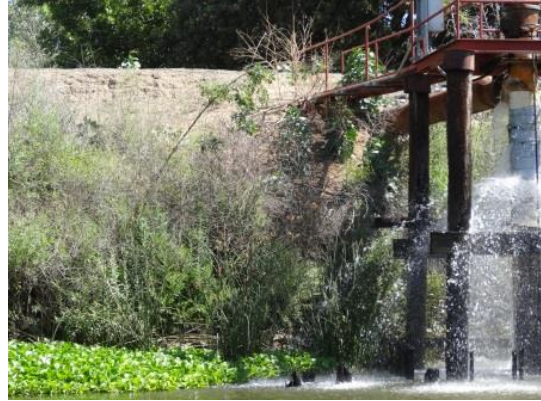
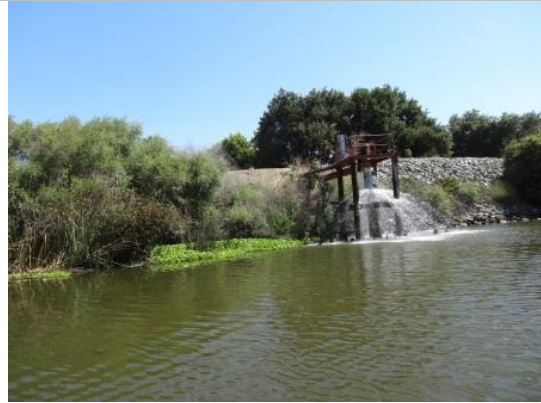
LM Start	0.46	Rating **	M	Issue No.	5
LM End	0.46	Issue Type +	Ma	Location *	WS
Category	Supplemental			GPS Latitude/Longitude	
				Start	End
Item	DWR Erosion Survey			37.809394 °	37.809394 °
				-121.392791 °	-121.392791 °
DWR ID					
Action/Comments					
Inspector Comments: 06/25/2015: No significant change observed. 07/02/2014: No significant change observed. 08/13/2013: No significant change observed. 08/07/2012: The site has been visited by boat survey. No significant change observed 08/23/2011: The site shows loose material around the pipe crossing. The operation of the pipe might have caused an impact on the levee. [2015 Site ID:RD2089U01RM29.8]

Close view of the site.

Front view of the site.

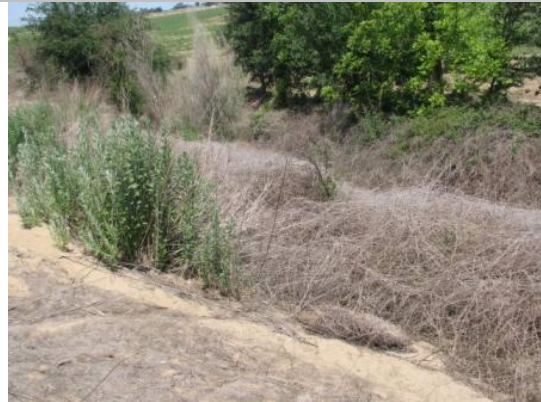
Photo 1 of 1 : FA\_2015\_RD2089\_316\_30\_20150910\_00017.jpg

05/24/2011 Dead brush is too thick to allow access and visibility of landside slope and toe.

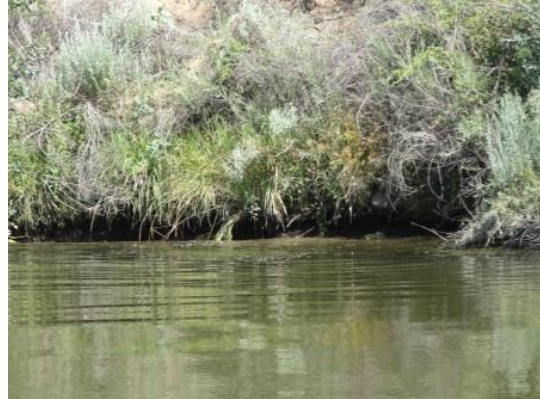
Photo 1 of 3 : SJR2015\_RD2089U01RM29.61\_3.jpg

Inspector Comments: 06/25/2015: No significant change observed.  
 07/02/2014: No significant change observed.  
 08/13/2013: No significant change observed.  
 08/07/2012: The site has been visited by boat survey. No significant change observed  
 08/23/2011: The 5-foot vertical scarp shows no significant change from the last year inspection. No new erosion activities observed. Dense white willow trees on site.  
 09/07/2010: It was difficult to view the erosion due to the thick Willow thickets and other vegetation at the water line. At the time of the inspection, there were no signs of repair on site. As noted during the last survey, there is a 5-foot vertical scarp along the lower slope that may be subjected to high flow velocities.  
 08/05/2010: Recommended for repair, per CLRO; "Erosion of this site may be subjective to rapid rates of erosion."  
 09/28/2009: No major change observed; 5-foot vertical scarp is immediately downstream of where berm has tapered; site is recommended as local maintenance issue, per CLRO CES Evaluation 2008 Report; Site # is the same as RM29.6, LM0.60; previously rated "U".

11/05/2008: No change observed; rodent holes on lower slope; wide levee crown. [2015 Site ID:RD2089U01RM29.61]

Front view of the site. Note the erosion is invisible because of the dense vegetation.

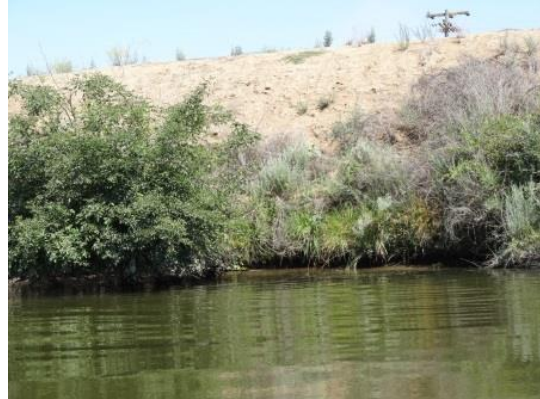
Photo 2 of 3 : SJR2015\_RD2089U01RM29.61\_4.jpg

Inspector Comments: 06/25/2015: No significant change observed.  
 07/02/2014: No significant change observed.  
 08/13/2013: No significant change observed.  
 08/07/2012: The site has been visited by boat survey. No significant change observed  
 08/23/2011: The 5-foot vertical scarp shows no significant change from the last year inspection. No new erosion activities observed. Dense white willow trees on site.  
 09/07/2010: It was difficult to view the erosion due to the thick Willow thickets and other vegetation at the water line. At the time of the inspection, there were no signs of repair on site. As noted during the last survey, there is a 5-foot vertical scarp along the lower slope that may be subjected to high flow velocities.  
 08/05/2010: Recommended for repair, per CLRO; "Erosion of this site may be subjective to rapid rates of erosion."  
 09/28/2009: No major change observed; 5-foot vertical scarp is immediately downstream of where berm has tapered; site is recommended as local maintenance issue, per CLRO CES Evaluation 2008 Report; Site # is the same as RM29.6, LM0.60; previously rated "U".

11/05/2008: No change observed; rodent holes on lower slope; wide levee crown. [2015 Site ID:RD2089U01RM29.61]

Front view of the site. The scarp is visible on the slope.

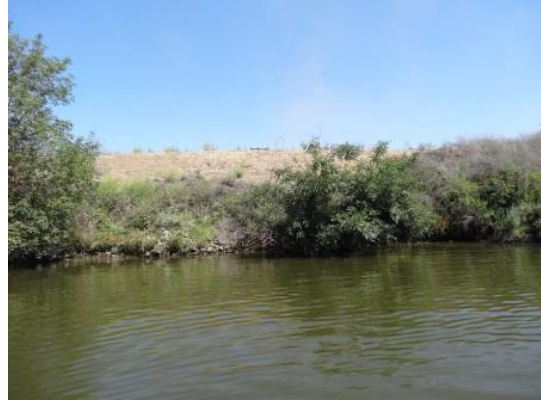
Photo 3 of 3 : SJR2015\_RD2089U01RM29.61\_9.jpg

LM Start	0.67	Rating **	U	Issue No.	3 (cont)	
LM End	0.67	Issue Type +	Ma	Location *	WS	
Category	Supplemental			GPS Latitude/Longitude		
				Start	End	
Item	DWR Erosion Survey			37.809780 °	37.809780 °	
				-121.396230 °	-121.396230 °	
DWR ID						
Action/Comments						
Inspector Comments: 06/25/2015: No significant change observed. 07/02/2014: No significant change observed. 08/13/2013: No significant change observed. 08/07/2012: The site has been visited by boat survey. No significant change observed 08/23/2011: The 5-foot vertical scarp shows no significant change from the last year inspection. No new erosion activities observed. Dense white willow trees on site. 09/07/2010: It was difficult to view the erosion due to the thick Willow thickets and other vegetation at the water line. At the time of the inspection, there were no signs of repair on site. As noted during the last survey, there is a 5-foot vertical scarp along the lower slope that may be subjected to high flow velocities. 08/05/2010: Recommended for repair, per CLRO; "Erosion of this site may be subjective to rapid rates of erosion." 09/28/2009: No major change observed; 5-foot vertical scarp is immediately downstream of where berm has tapered; site is recommended as local maintenance issue, per CLRO CES Evaluation 2008 Report; Site # is the same as RM29.6, LM0.60; previously rated "U". 11/05/2008: No change observed; rodent holes on lower slope; wide levee crown. [2015 Site ID:RD2089U01RM29.61]

Front view of the site.

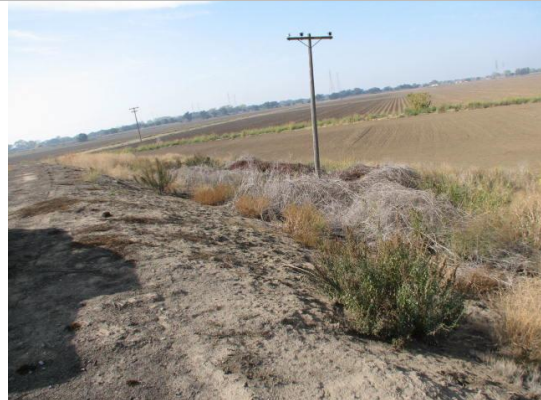
Photo 1 of 1 : FA\_2015\_RD2089\_316\_20\_20150910\_00013.jpg

11/10/2011 Vegetation obstructs visibility of slope and toe.

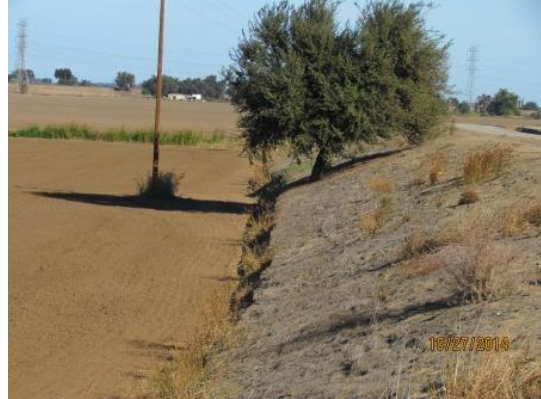
Photo 1 of 1 : FA\_2015\_RD2089\_316\_17\_20150910\_00010.jpg

LM Start	0.81	Rating **	M	Issue No.	17
LM End	0.94	Issue Type +	Ma	Location *	LS
Category	Earthen Levee			GPS Latitude/Longitude	
				Start	End
Item	Slope Stability			37.808319 °	37.806453 °
				-121.397881 °	-121.397755 °
DWR ID	DWR_RD2089_01_f_2014_17				
Action/Comments					
Repair slope instability.					
Inspector Comments: Landside levee toe cut due to farming.

View of the vertical cut along the landside levee toe.

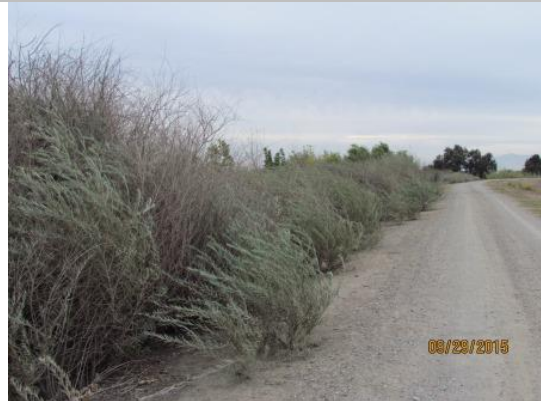
Photo 1 of 1 : FA\_2015\_RD2089\_316\_36\_20151005\_00040.jpg

View of tall willows obstructing visibility on waterside slope.

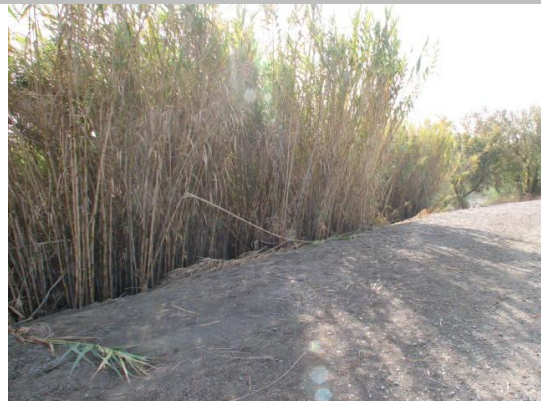
Photo 1 of 1 : FA\_2015\_RD2089\_316\_33\_20150910\_00019.jpg

11/10/2011 Arundo on upper 20' of waterside slope.

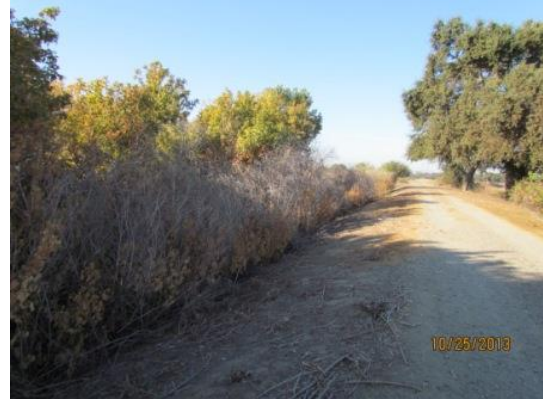
Photo 1 of 1 : FA\_2015\_RD2089\_316\_35\_20150910\_00020.jpg

Thick vegetation on upper 20' of waterside slope obstructing visibility and access.

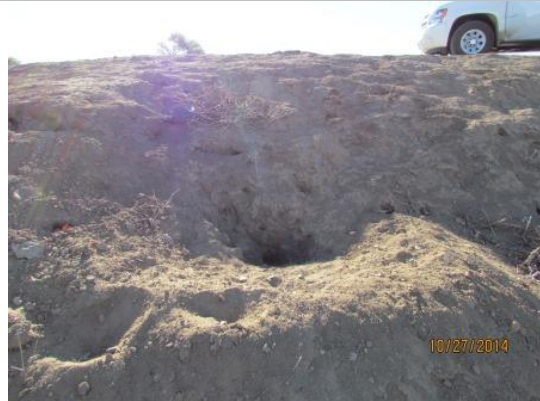
Photo 1 of 1 : FA\_2015\_RD2089\_316\_16\_20150910\_00009.jpg

View of the rodent burrow on the landside levee slope.

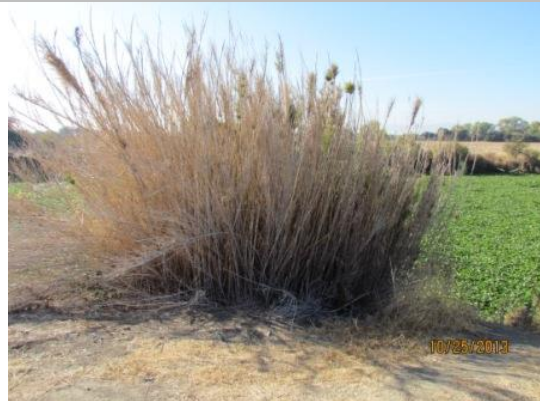
Photo 1 of 1 : FA\_2015\_RD2089\_316\_25\_20150910\_00015.jpg

View of the Arrundo on the waterside slope obstructing visibility. LMA is actively trying to remove the wild growth.

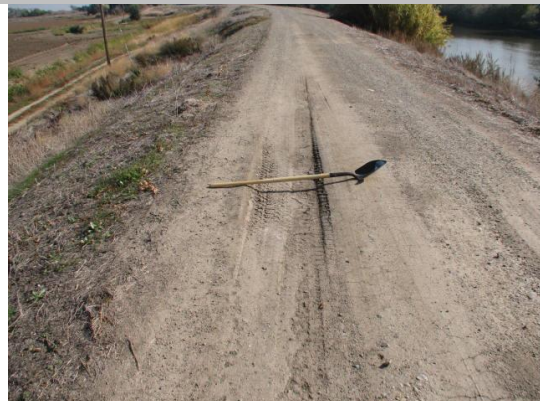
Photo 1 of 1 : FA\_2015\_RD2089\_316\_43\_20150910\_00023.jpg

11/10/2011 Depression in roadway.

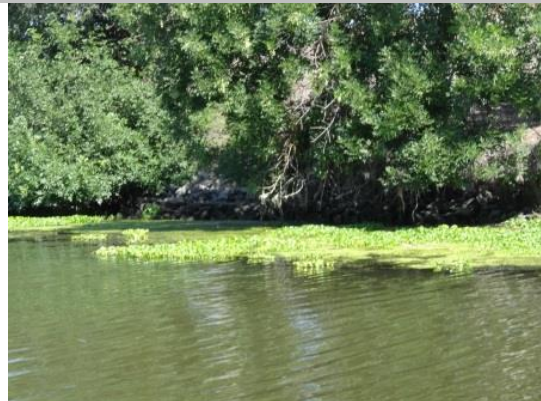
Photo 2 of 2 : SJR2015\_RD2089U01RM29.04\_4.JPG

Close view of the site. Note the tree and the vegetation.

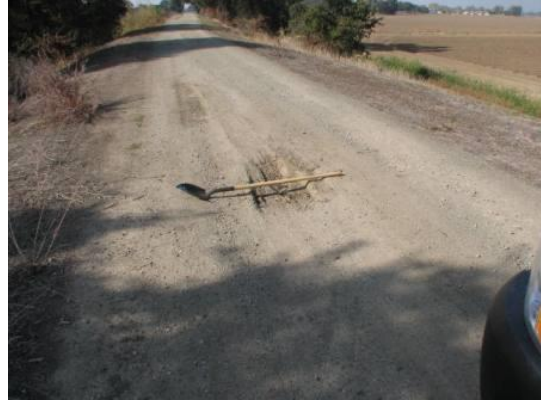
Photo 1 of 1 : FA\_2015\_RD2089\_316\_45\_20150910\_00025.jpg

11/10/2011 Roadway depression.

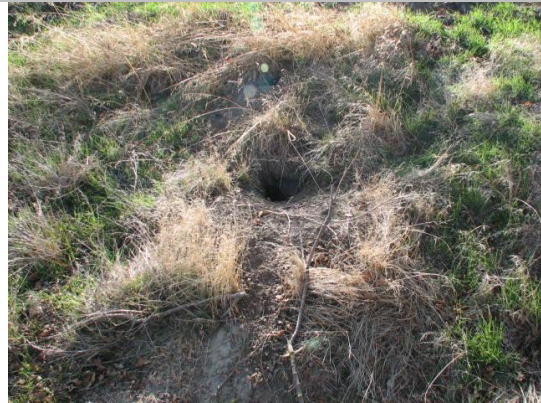
Photo 1 of 1 : FA\_2015\_RD2089\_316\_47\_20150910\_00027.jpg

11/10/2011 Active rodent burrow on landside slope.

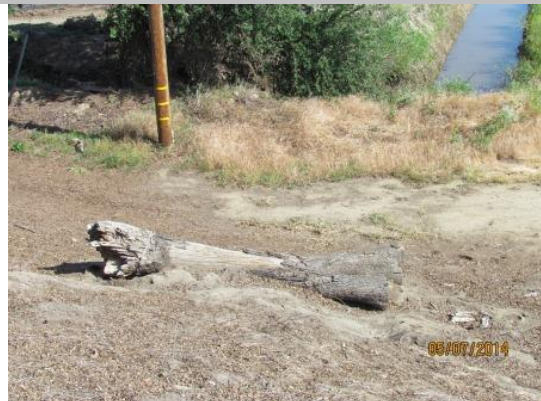
Photo 1 of 1 : FA\_2015\_RD2089\_316\_46\_20150910\_00026.jpg

Decaying tree at the landside levee toe is obstructing visibility and access.

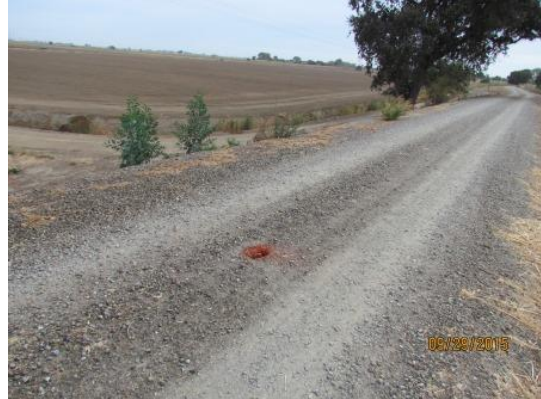
Photo 1 of 1 : FA\_2015\_RD2089\_316\_26\_20151005\_00041.jpg

View of the rodent hole on the levee crown.

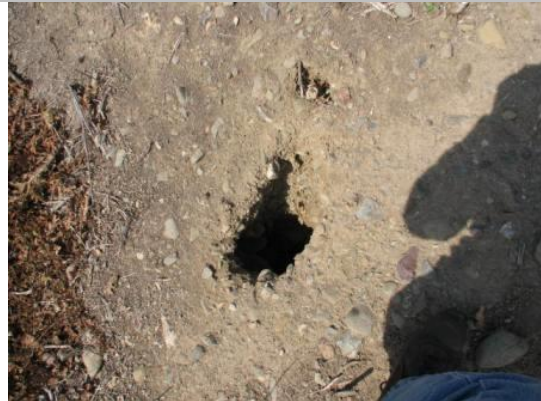
Photo 1 of 1 : FA\_2015\_RD2089\_316\_49\_20150910\_00028.jpg

11/10/2011 Deep burrow on waterside.

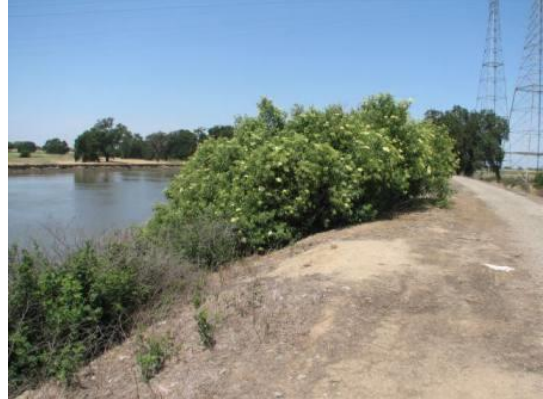
Photo 1 of 2 : FA\_2015\_RD2089\_317\_4\_20150910\_00003.jpg

05/24/2011 Updated photo of issue noted in Fall 2010 inspection.

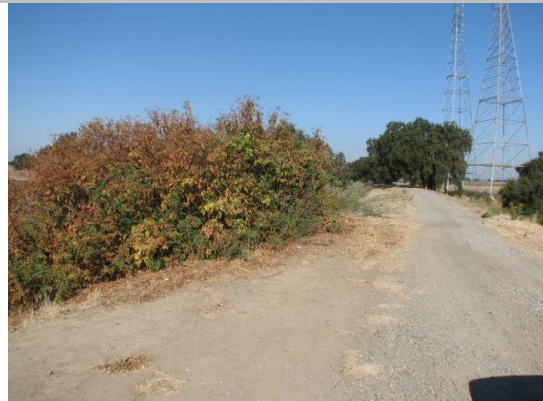
Photo 2 of 2 : FA\_2015\_RD2089\_317\_4\_20150910\_00004.jpg

Fall 2009 photo of unacceptable vegetation on levee slope.

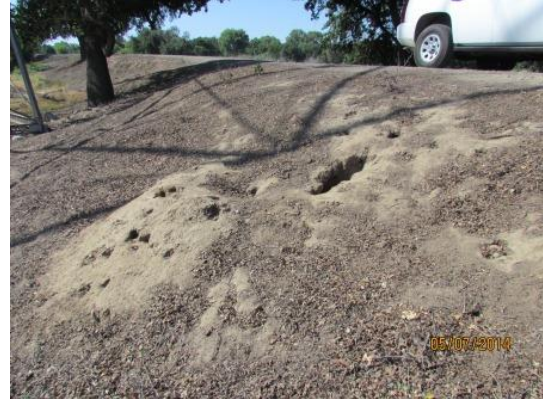
Photo 1 of 1 : FA\_2015\_RD2089\_317\_48\_20150910\_00031.jpg

View of the rodent burrow on the landside levee slope.

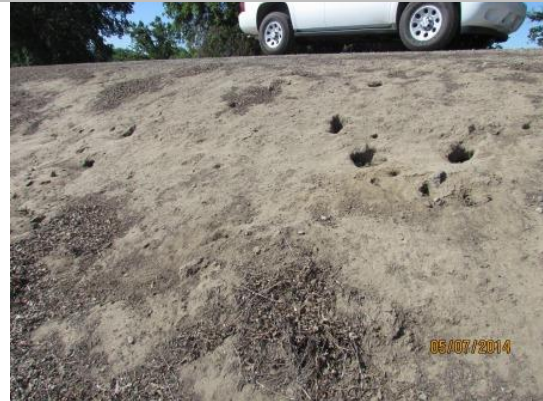
Photo 1 of 1 : FA\_2015\_RD2089\_317\_49\_20150910\_00032.jpg

View of the multiple rodent burrows on the landside levee hinge and slope.

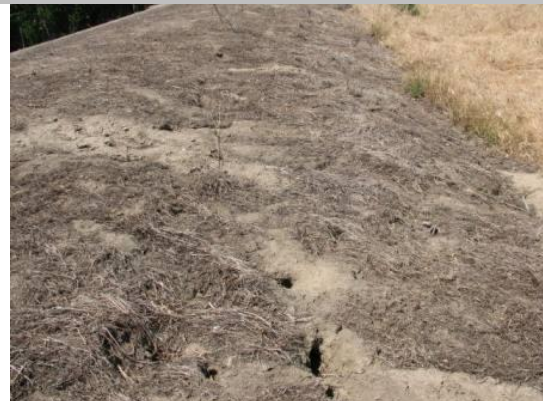
Photo 1 of 1 : FA\_2015\_RD2089\_317\_24\_20150910\_00023.jpg

05/24/2011 Active burrows, ground squirrel sighted in area.

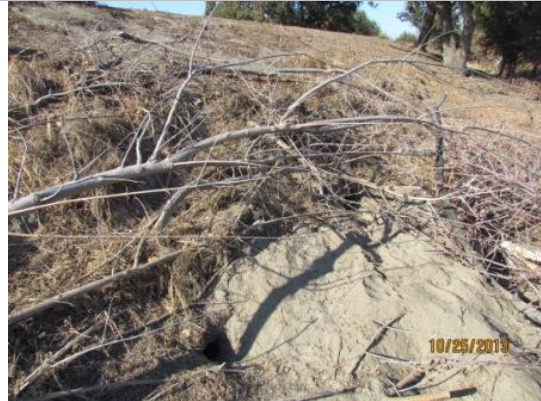
Photo 1 of 1 : FA\_2015\_RD2089\_317\_51\_20150910\_00033.jpg

View of the rodent burrow on the landside levee toe.

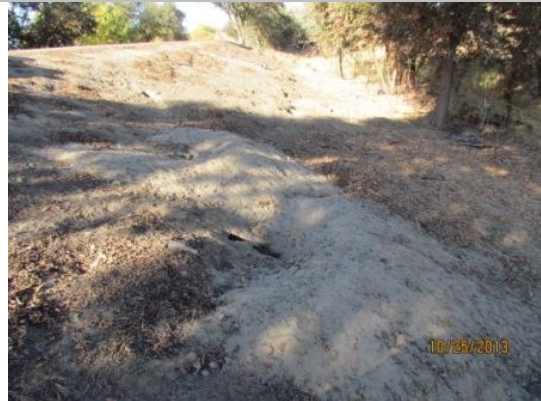
Photo 1 of 3 : FA\_2015\_RD2089\_317\_53\_20150910\_00035.jpg

LM Start	0.30	Rating **	U	Issue No.	53
LM End	0.31	Issue Type +	Ma	Location *	LS
Category	Earthen Levee			GPS Latitude/Longitude	
				Start	End
Item	Animal Control			37.809977 °	37.810022 °
				-121.411189 °	-121.411387 °
DWR ID	DWR_RD2089_02_f_2013_53				
Action/Comments					
Exterminate rodents and backfill and compact or grout burrows. Inspector Comments: Exterminating rodents and grouting the burrows recommended.

View of the multiple rodent burrows on the landside levee slope.

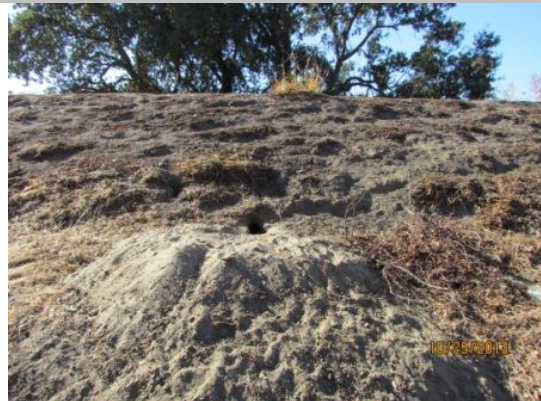
Photo 2 of 3 : FA\_2015\_RD2089\_317\_53\_20150910\_00036.jpg

View of the rodent burrow on the landside levee slope.

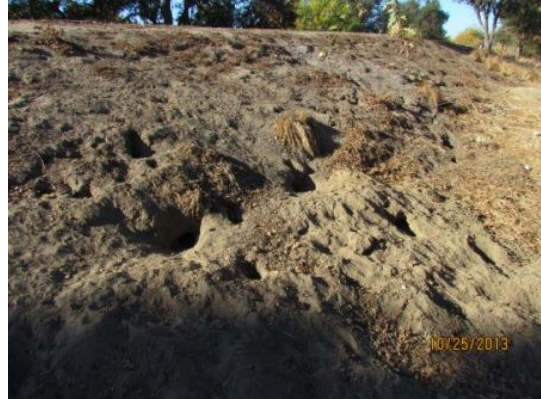
Photo 3 of 3 : FA\_2015\_RD2089\_317\_53\_20150910\_00037.jpg

LM Start	0.30	Rating **	U	Issue No.	53 (cont)
LM End	0.31	Issue Type +	Ma	Location *	LS
Category	Earthen Levee			GPS Latitude/Longitude	
				Start	End
Item	Animal Control			37.809977 °	37.810022 °
				-121.411189 °	-121.411387 °
DWR ID	DWR_RD2089_02_f_2013_53				
Action/Comments					
Exterminate rodents and backfill and compact or grout burrows. Inspector Comments: Exterminating rodents and grouting the burrows recommended.

Another view of the multiple rodent burrows on the landside levee slope.

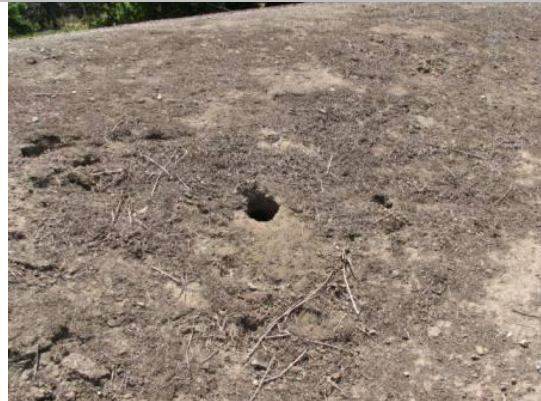
Photo 1 of 1 : FA\_2015\_RD2089\_317\_26\_20150910\_00024.jpg

LM Start	0.36	Rating **	M	Issue No.	26
LM End	0.36	Issue Type +	Ma	Location *	LS
Category	Earthen Levee			GPS Latitude/Longitude	
				Start	End
Item	Animal Control			37.810125 °	37.810125 °
				-121.412317 °	-121.412317 °
DWR ID	DWR_RD2089_02_s_2012_26				
Action/Comments					
No rodents visible, but rodent burrows visible; need to backfill and compact or grout burrows.					
Inspector Comments: Active burrow needs to be repaired.

05/24/2011 Active rodent burrow.

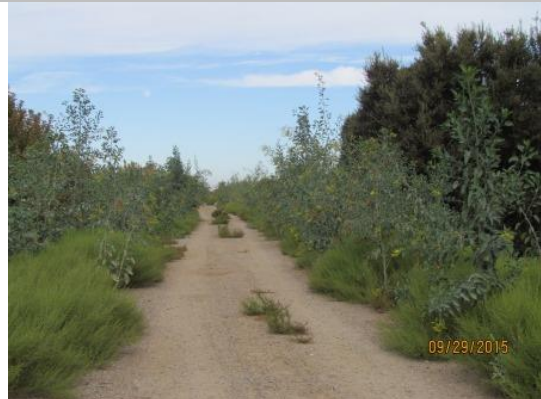
Photo 1 of 1 : FA\_2015\_RD2089\_317\_8\_20151005\_00041.jpg

View of tall vegetation limiting visibility and access on the levee.

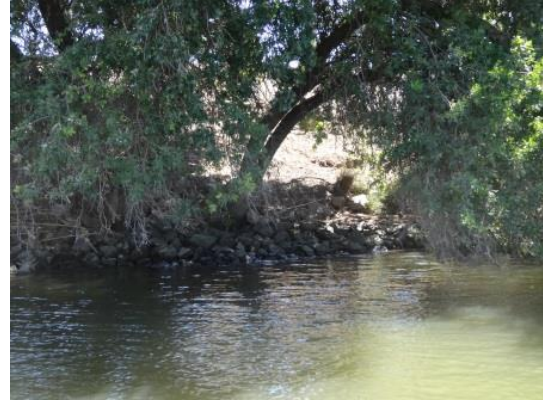
Photo 1 of 2 : SJR2015\_RD2089U02RM28.35\_7.jpg

View of the site from the survey boat.

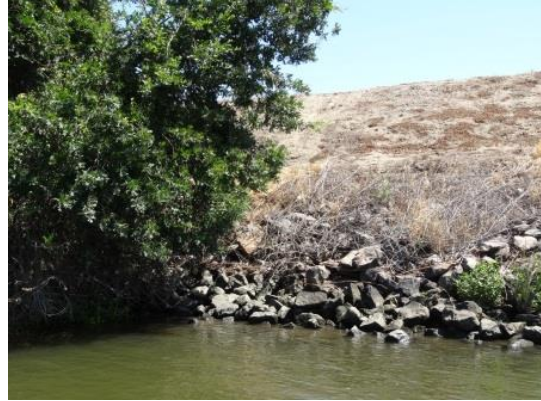
Photo 2 of 2 : SJR2015\_RD2089U02RM28.35\_8.jpg

Action/Comments					
Inspector Comments: 06/25/2015: No significant change observed. 07/02/2014: No significant change observed. 08/13/2013: No significant change observed. 08/07/2012: The site has been visited by boat survey. No significant change observed. 08/23/2011: No significant change observed on site. 09/07/2010: Site consists of a jutting rip rap that has created an eddy, scouring the levee slope. Most sections of the toe and lower slope are lined with rip rap. However, the rip rap is sloughing on the mid slope and at the toe, exposing the underlying soils and tree roots. The remaining revetment is no longer adequately protecting the slope. There are 3 Sycamore trees at the toe with exposed tree roots. 08/05/2010: Recommended for repair, per CLRO. 09/28/2009: Pocket erosion on lower slope just above the toe rip rap; protruding rip rap upstream is creating an eddy, scouring the levee slope; Site # is the same as RM28.40, LM0.30; previously rated "U"; pictures will be made available during the next survey. 11/05/2008: Cut into levee profile; riprap slide; rodent holes; pictures do not match GPS and current condition. [2015 Site ID:RD2089U02RM28.35]

View of the site from the survey boat.

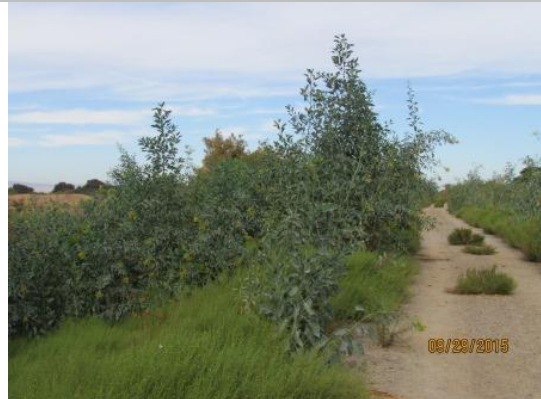
Photo 1 of 1 : FA\_2015\_RD2089\_317\_28\_20151005\_00042.jpg

View of the tall vegetation obstructing visibility and access.

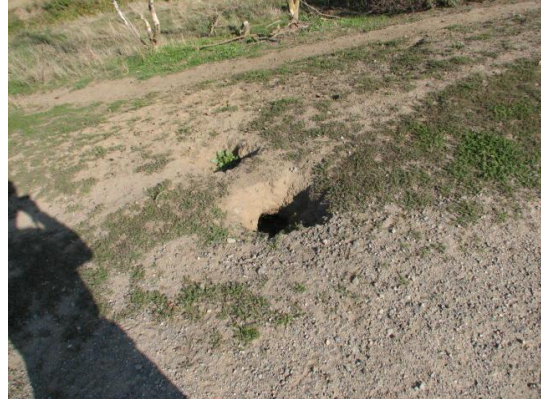
Photo 1 of 1 : FA\_2015\_RD2089\_317\_13\_20150910\_00015.jpg

11/10/2011 Two large burrows on crown, need to be filled.

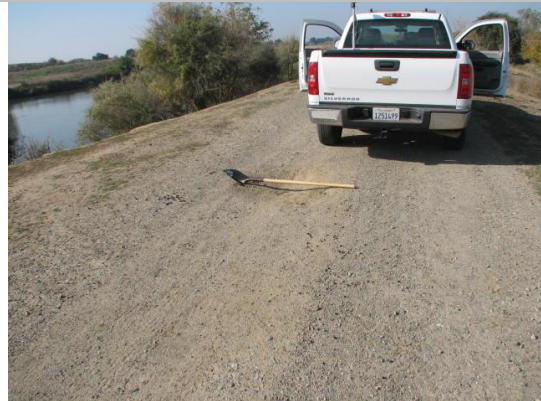
Photo 1 of 1 : FA\_2015\_RD2089\_317\_10\_20150910\_00011.jpg

11/10/2011 Depression in crown needs to be filled.

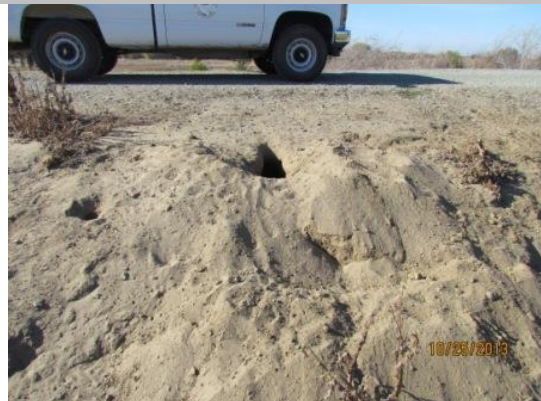
Photo 1 of 1 : FA\_2015\_RD2089\_317\_54\_20150910\_00038.jpg

View of the rodent burrow on the landside levee slope.

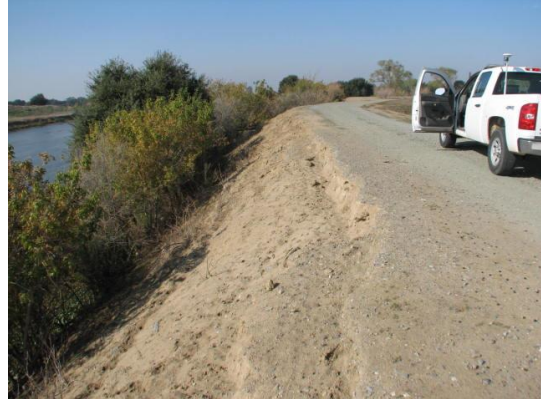
Photo 1 of 1 : FA\_2015\_RD2089\_317\_14\_20150910\_00016.jpg

11/10/2011 Approximately 1' scarp has been created by livestock travel.

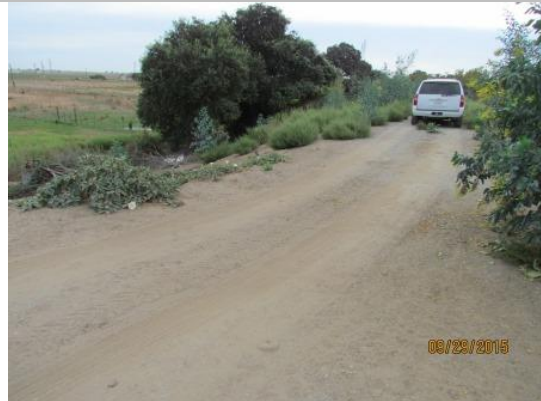
Photo 1 of 4 : FA\_2015\_RD2089\_317\_35\_20151005\_00044.jpg

View of the levee crown depression looking upstream.

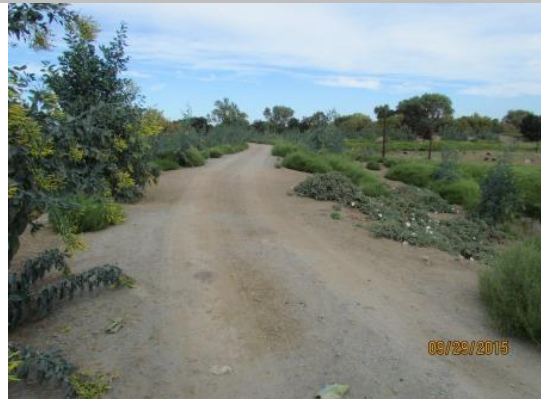
Photo 2 of 4 : FA\_2015\_RD2089\_317\_35\_20151005\_00045.jpg

View of the levee crown depression looking downstream.

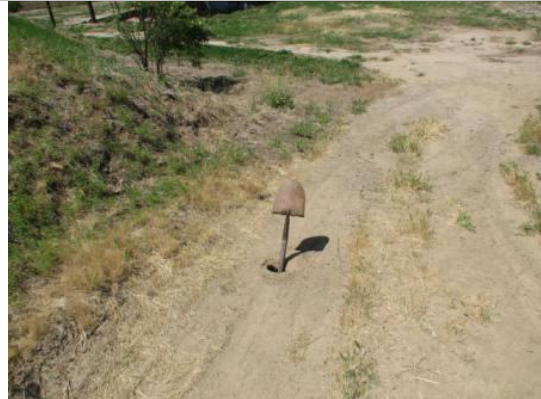
Photo 1 of 3 : FA\_2015\_RD2089\_317\_40\_20150910\_00028.jpg

05/24/2011 Deep vertical burrow in ramp on land side of levee.

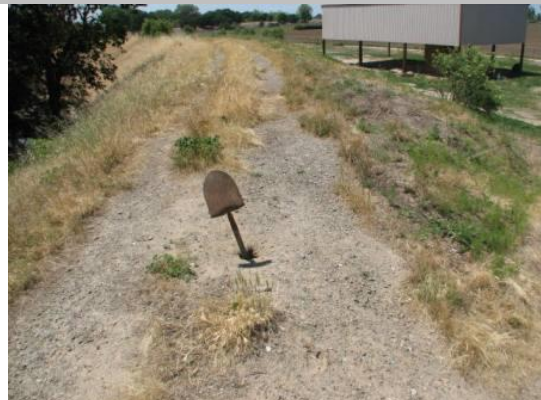
Photo 2 of 3 : FA\_2015\_RD2089\_317\_40\_20150910\_00029.jpg

05/24/2011 Deep vertical burrow in levee crown.

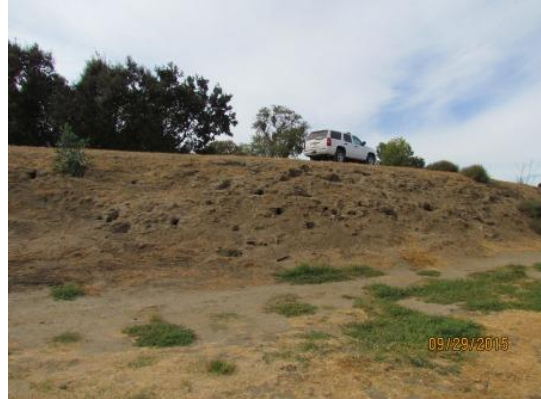
Photo 3 of 3 : FA\_2015\_RD2089\_317\_40\_20151005\_00043.jpg

View of the multiple rodent holes on the landside levee slope.

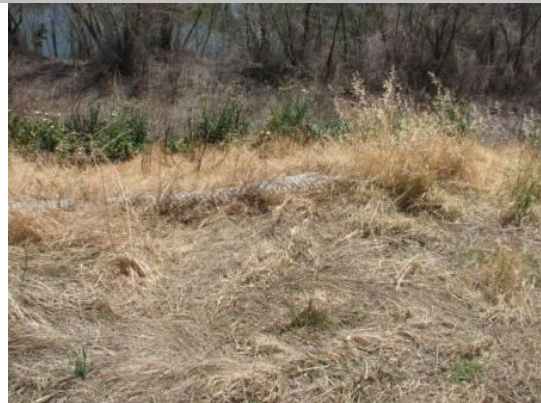
Photo 1 of 1 : FA\_2015\_RD2089\_317\_41\_20150910\_00030.jpg

05/24/2011 Old CMP left on waterside levee slope, needs to be removed.

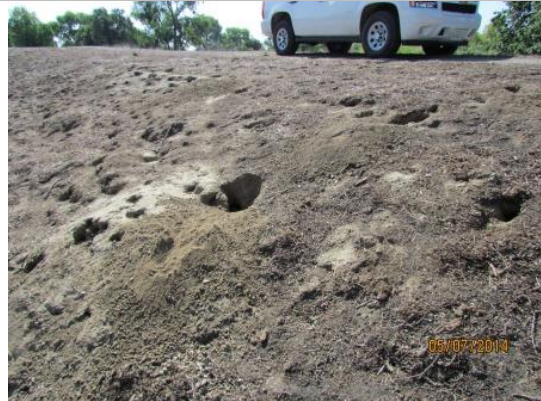
Photo 1 of 1 : FA\_2015\_RD2089\_317\_5\_20150910\_00005.jpg

View of the rodent holes on the landside levee slope.

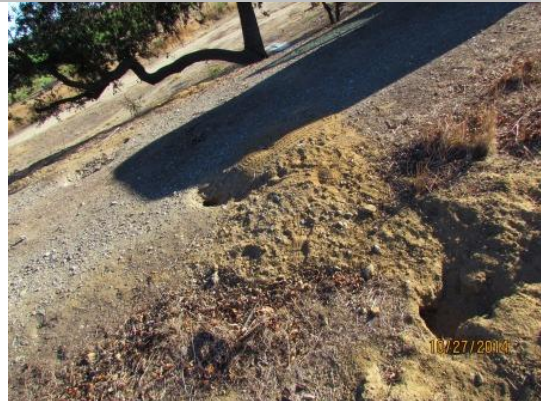
Photo 1 of 2 : FA\_2015\_RD2089\_317\_12\_20150910\_00013.jpg

View of several large rodent holes on the levee crown.

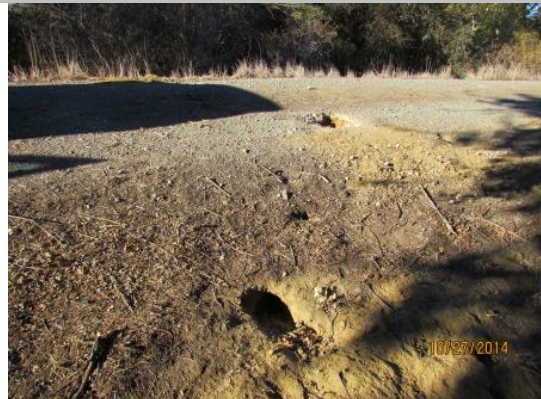
Photo 2 of 2 : FA\_2015\_RD2089\_317\_12\_20150910\_00014.jpg

View of several rodent burrows on landside levee hinge and crown.

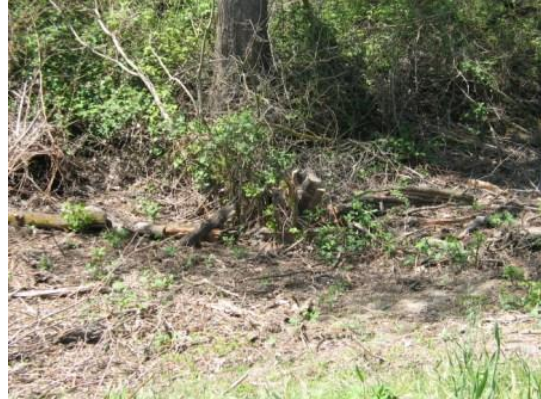
Photo 1 of 1 : FA\_2015\_RD2089\_317\_29\_20150910\_00026.jpg

Tree stump &gt;2" left after vegetation and tree removal.

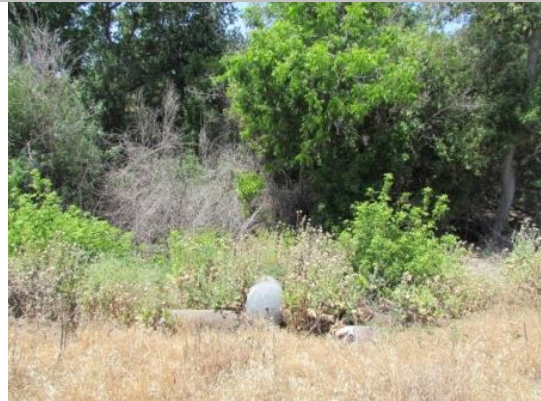
Photo 1 of 1 : FA\_2015\_RD2089\_317\_17\_20150910\_00018.jpg

View of water tanks disposed on waterside slope.

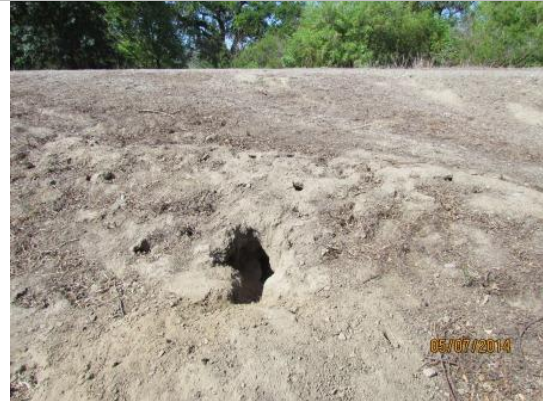
Photo 1 of 1 : FA\_2015\_RD2089\_317\_6\_20150910\_00006.jpg

View of the large rodent hole on the landside levee slope.

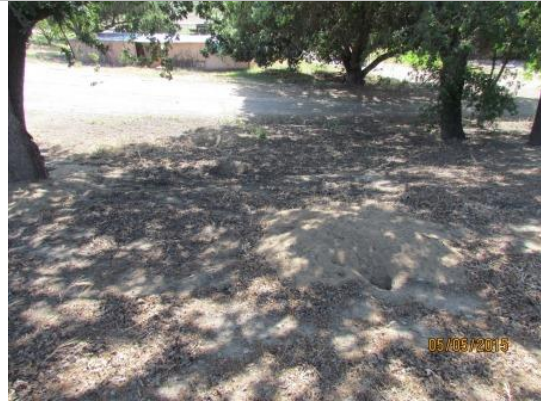
Photo 1 of 1 : FA\_2015\_RD2089\_317\_11\_20150910\_00012.jpg

View of the multiple rodent burrows on the landside levee slope.
